### Case Study:

# Permanent Conductivity for Safer Fueling Systems

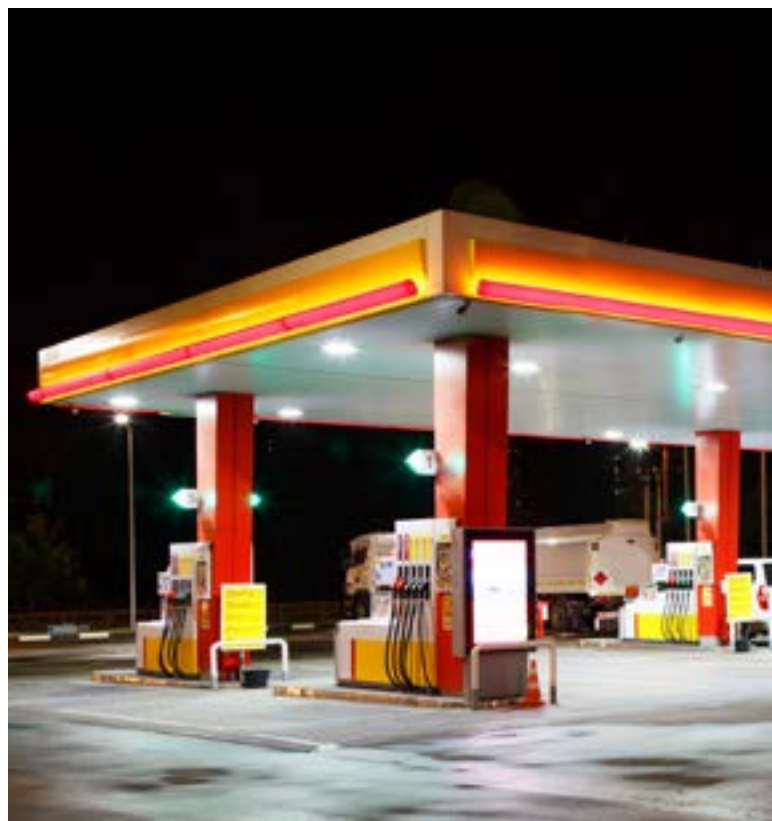
- **Low surface resistivity** ( $<10^4 \Omega/\text{sq}$ ) ensuring permanent static-dissipative properties
- **Excellent mechanical properties** for strength and durability
- **Outstanding processability**—ideal melt-flow index and thermal stability for multilayer pipe co-extrusion and welding
- **Certified compliance** with ATEX, UL, and GB safety standards
- **This material forms the critical fourth layer** of OPW's five-layer fuel pipe, providing a continuous conductive path to safely dissipate static electricity.
